# 坡面排水與打樁編柵之 源頭治理方法與敏督利颱風後之成效評估

## An Evaluation of the Erosion Control Method with Slope Drainage, Staking and Wattling in Taiwan after Typhoon Mindulle

水土保持學報 37(3) : 251-262 (2005)

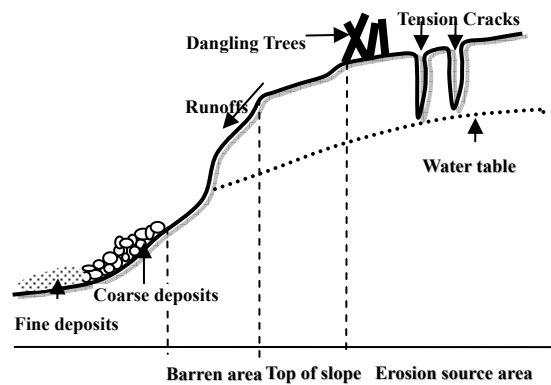
圖 2. 崩場地與不穩定邊坡問題示意圖  
Figure 2. Problems of a landslide and unstable slope.

Normally a landslide and unstable slope have some cracks on top of the slopes.

There may be tree dangling on slope face. Runoffs cause sheet/gully/rill/inter-rill erosion; and there are deposits near toe of slopes as shown in Figure 2. The method includes three major strategies of treatment, as following and is shown in Figure 3 & 4.

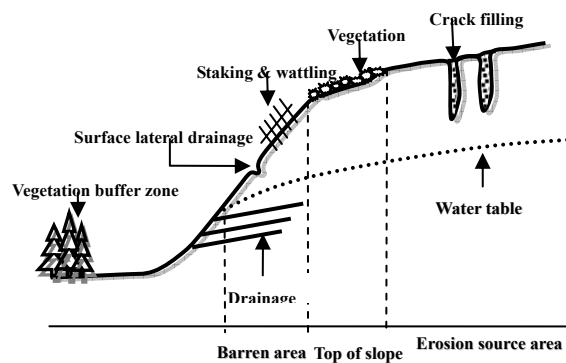
圖 3. 邊坡沖蝕控制處理示意圖  
Figure 3. Treatment of the erosion control method.

- Erosion source treatment on top of slope: backfill cracks, build lateral drain ditches, clean dangling trees, etc.
- Slope surface treatment: construct lateral and longitudinal drain ditches, perform staking and wattling (Figure 5), vegetate, etc.
- Treatment at toe and deposits: build toe ditches, construct soil nails, construct gabions, drill drainage pipes in slope toe, replant buffer zone, etc.

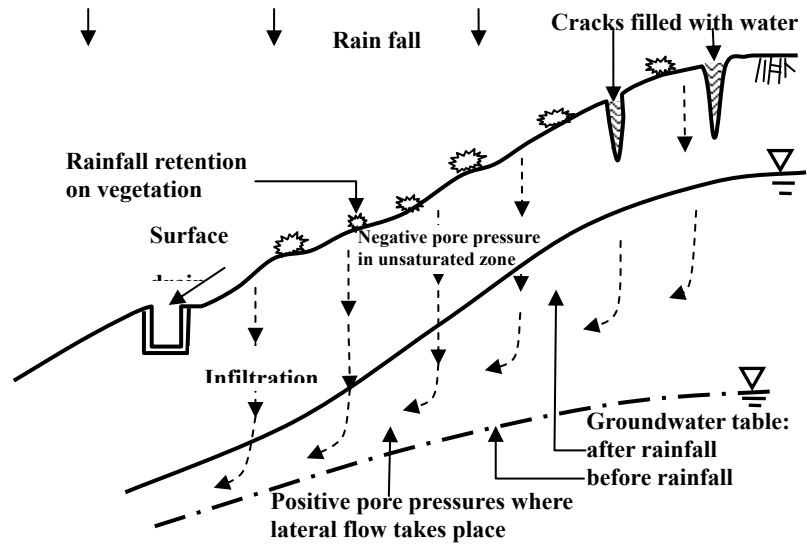
圖 6a. 邊坡未填補裂縫降雨入滲情形與可能地下水位示意圖

Figure 6a. Infiltration on slope and possible groundwater table after rainfall – before filling cracks.

If tension cracks on a slope are not treated and are filled by rainfall water, the groundwater table would be raised higher (Figure 6a). This will cause the slope materials to softening, reducing shear resistant strength (resistance) and increasing self-weight (driving force) of the slope. The safety factor of the slope will be greatly reduced. However, if the cracks are treated with fillings that prevent water from entering the slope (Figure 6b), the groundwater table would only be raised by infiltration and remains at a much lower level. The slope could have a relatively better stability.

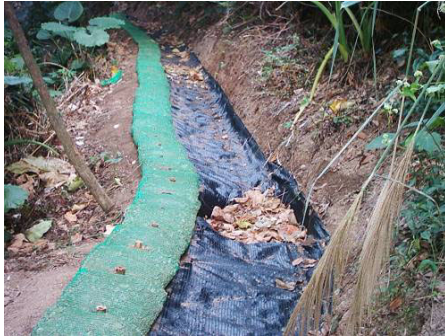
圖 7a. 邊坡坡頂回填透水材料截水 (5)  
Figure 7a. Water cutoff at top of slope by backfilling(5).

drainage ditch, waterfall, drainage pipe, etc. More environmental friendly treatments such as grass ditch, stone ditch, backfill-bag ditch, etc. Figures 7a~7d show some of the practical application of installing a drainage system for a slope on top, on the surface and at the toe.

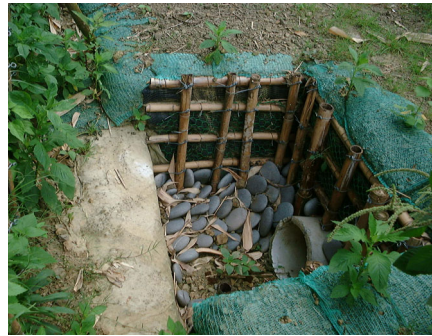
圖 7b. 採用自然資材設計之疊水工 (5)  
Figure 7b. Waterfall using natural materials (5).

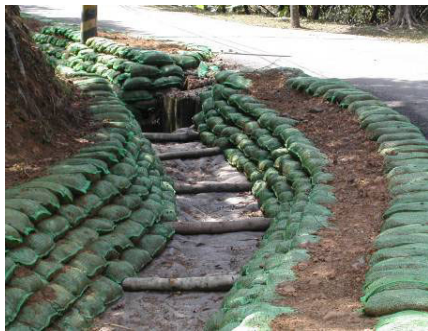
圖 7c. 坡趾掘溝排水 (5)  
Figure 7c. Ditch at toe (5).

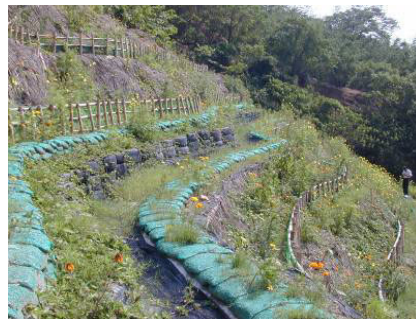
圖 7d. 坡面背填土袋橫向排水與植生 (5)  
Figure 7d. Backfill-bags for lateral drainage and vegetation on slope surface (5).

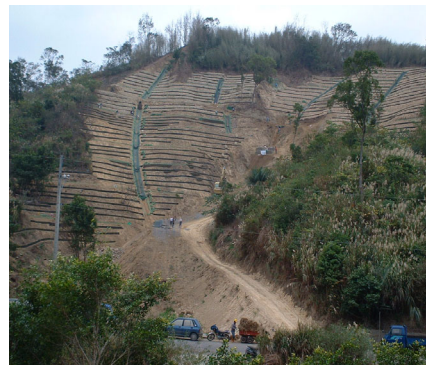
圖 8b. 崩場地處理現址-施工中(三灣鄉)  
Figure 8b. During construction.

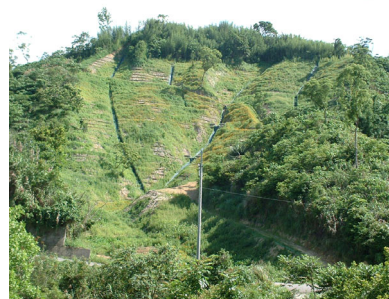
圖 8c. 崩場地處理現址-施工後(三灣鄉)  
Figure 8c. After construction.

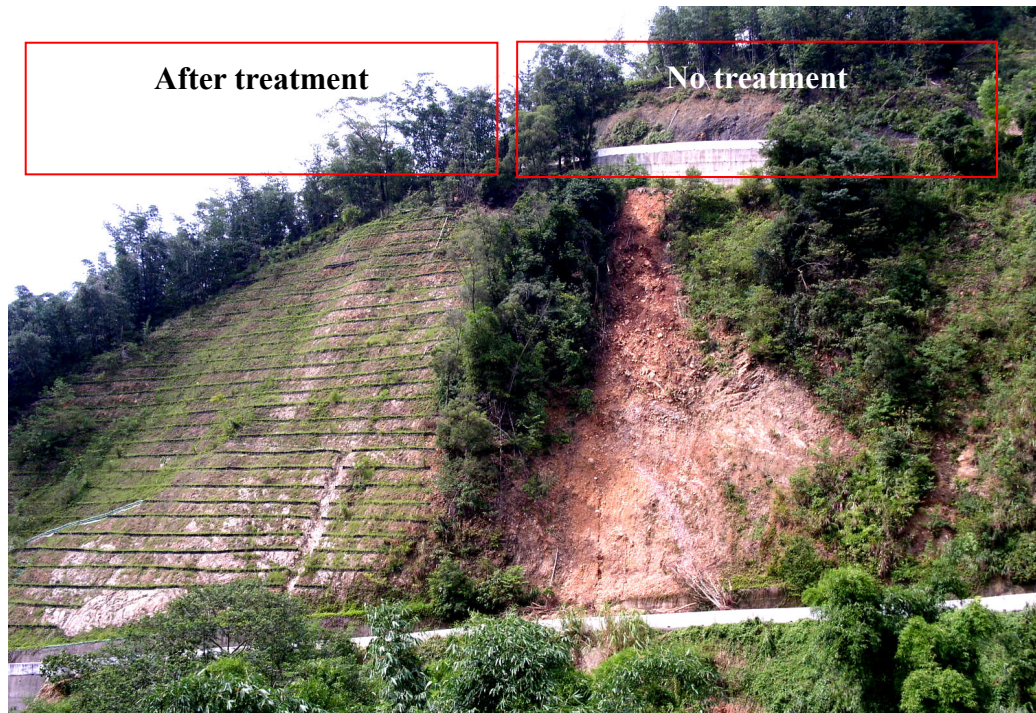
圖 9. 邊坡進行沖蝕控制處理與未處理影響比較 (2)

Figure 9. A Comparison of the Effect of the Erosion Control Method (2).

Properly designed erosion control method can be effective in stabilization a landslide area and restoration of a local ecosystem. During planning and design stages of mitigations, factors such as safety, ecology, landscape, geomorphology, and hydrology should be comprehensively considered. It is often found that after a landslide area is stabilized, the ecosystems reinstate gradually after using the erosion control method(2). A successful example site in Sanwan Xiang, Taiwan, adopting the erosion control method is shown in Figure 8a~8c for before, during and after the construction. The landscape scene after re-vegetation is satisfied. Figure 9 shows a comparison between with and without the erosion control method at a same site. It is obvious that the part with the treatment is stable and re-vegetates very well without further erosion.
